Slope Evolution at Calvert Cliffs, Maryland

Measuring the Change from Eroding Bluffs to Stable Slopes

Martha Herzog. National Oceanic and Atmospheric Administration. Silver Spring, MD
Curt Larsen and Michele McRae. United States Geological Survey. Reston, VA

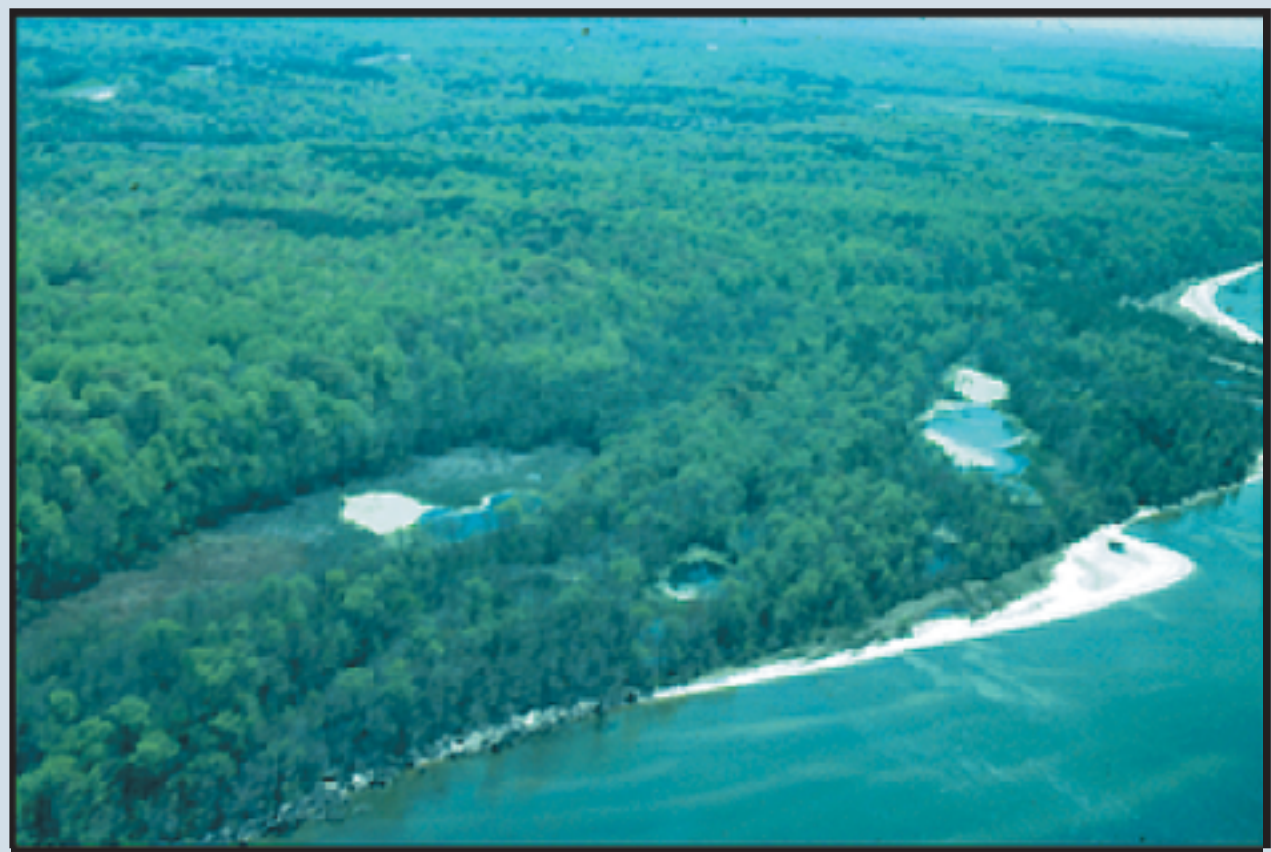
An aerial view of Flag Ponds. The ridge line is apparent behind the marsh area.

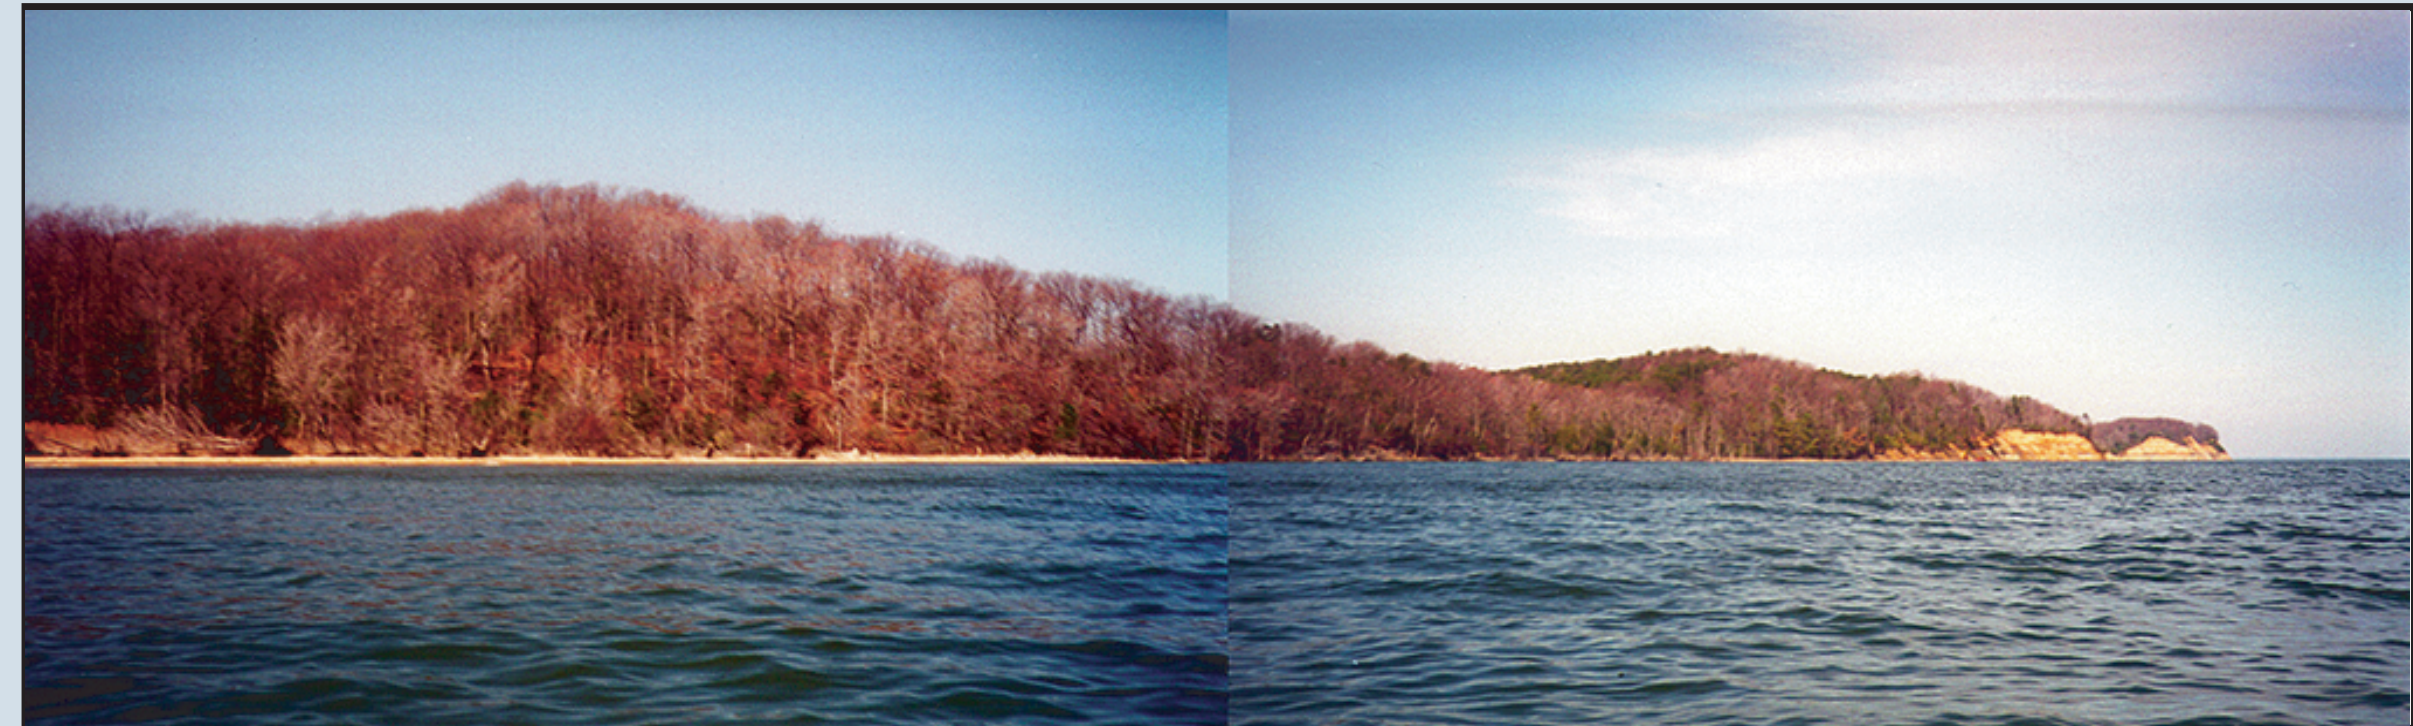
These photographs taken north of Point illustrate the migratory history of the area. As the slope protection migrates south (left) the bluffs become exposed to wave action (right).

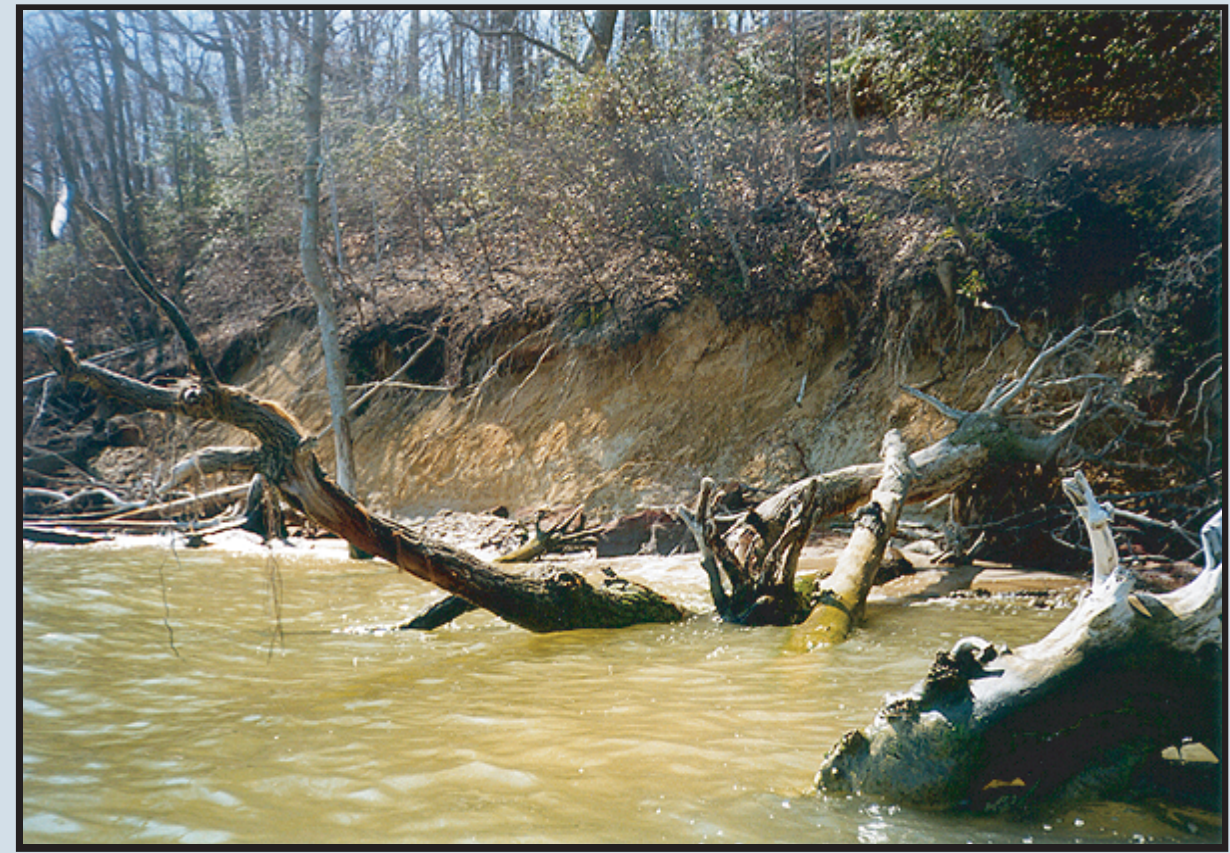
Active erosion at the north end of Cove Point.

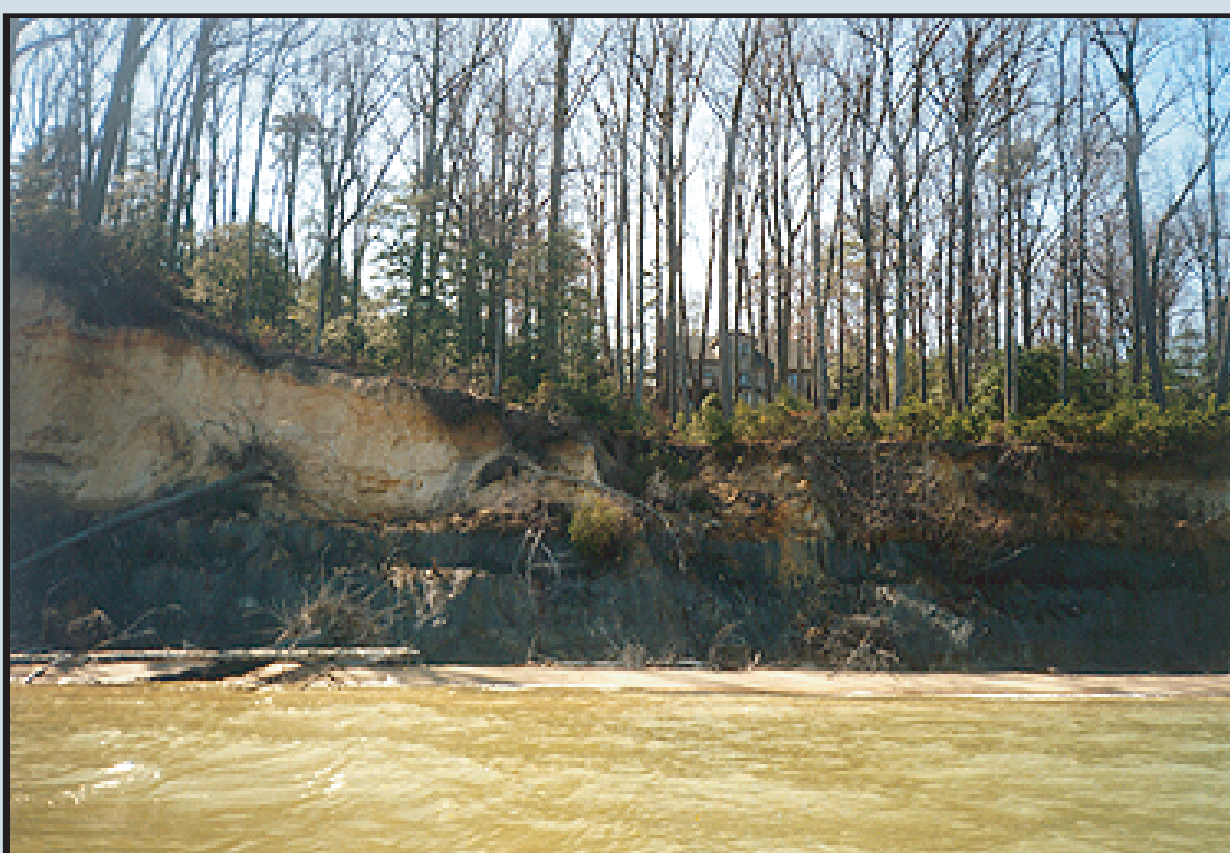
Much of the Calvert Cliffs such as the southern end of Cove Point and the northern end of Flag Ponds support privately owned waterfront communities and businesses. This is a typical example of development at the eroding bluffs.

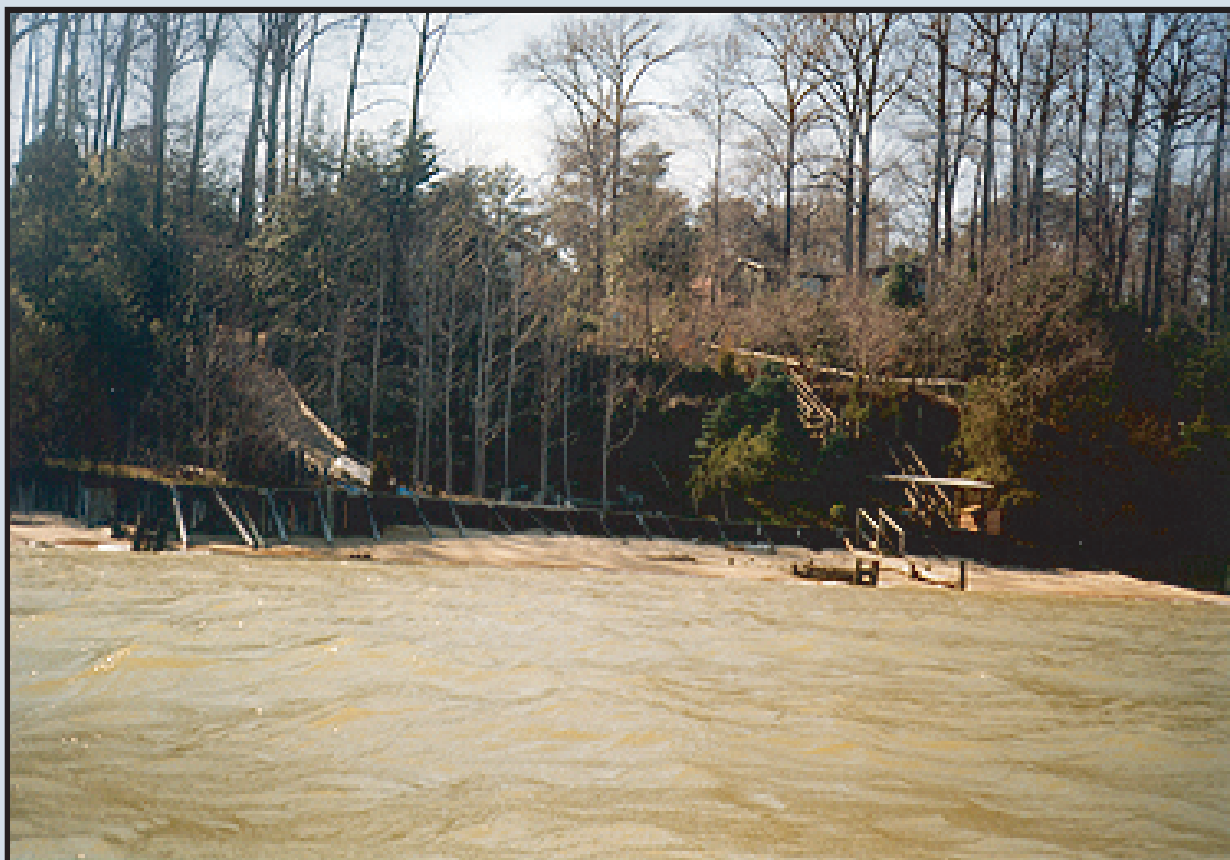
Many of the residences in the Calvert Cliffs area have installed a variety of erosion control measures such as groins, bulkheads, and rip-rap. This is one example of such measures at the south end of Cove Point.
